# Walk Around

## Focke-Wulf Fw 190A/F

Walk Around Number 22  
squadron/signal publications

By Malcolm Laing and E. Brown Ryle

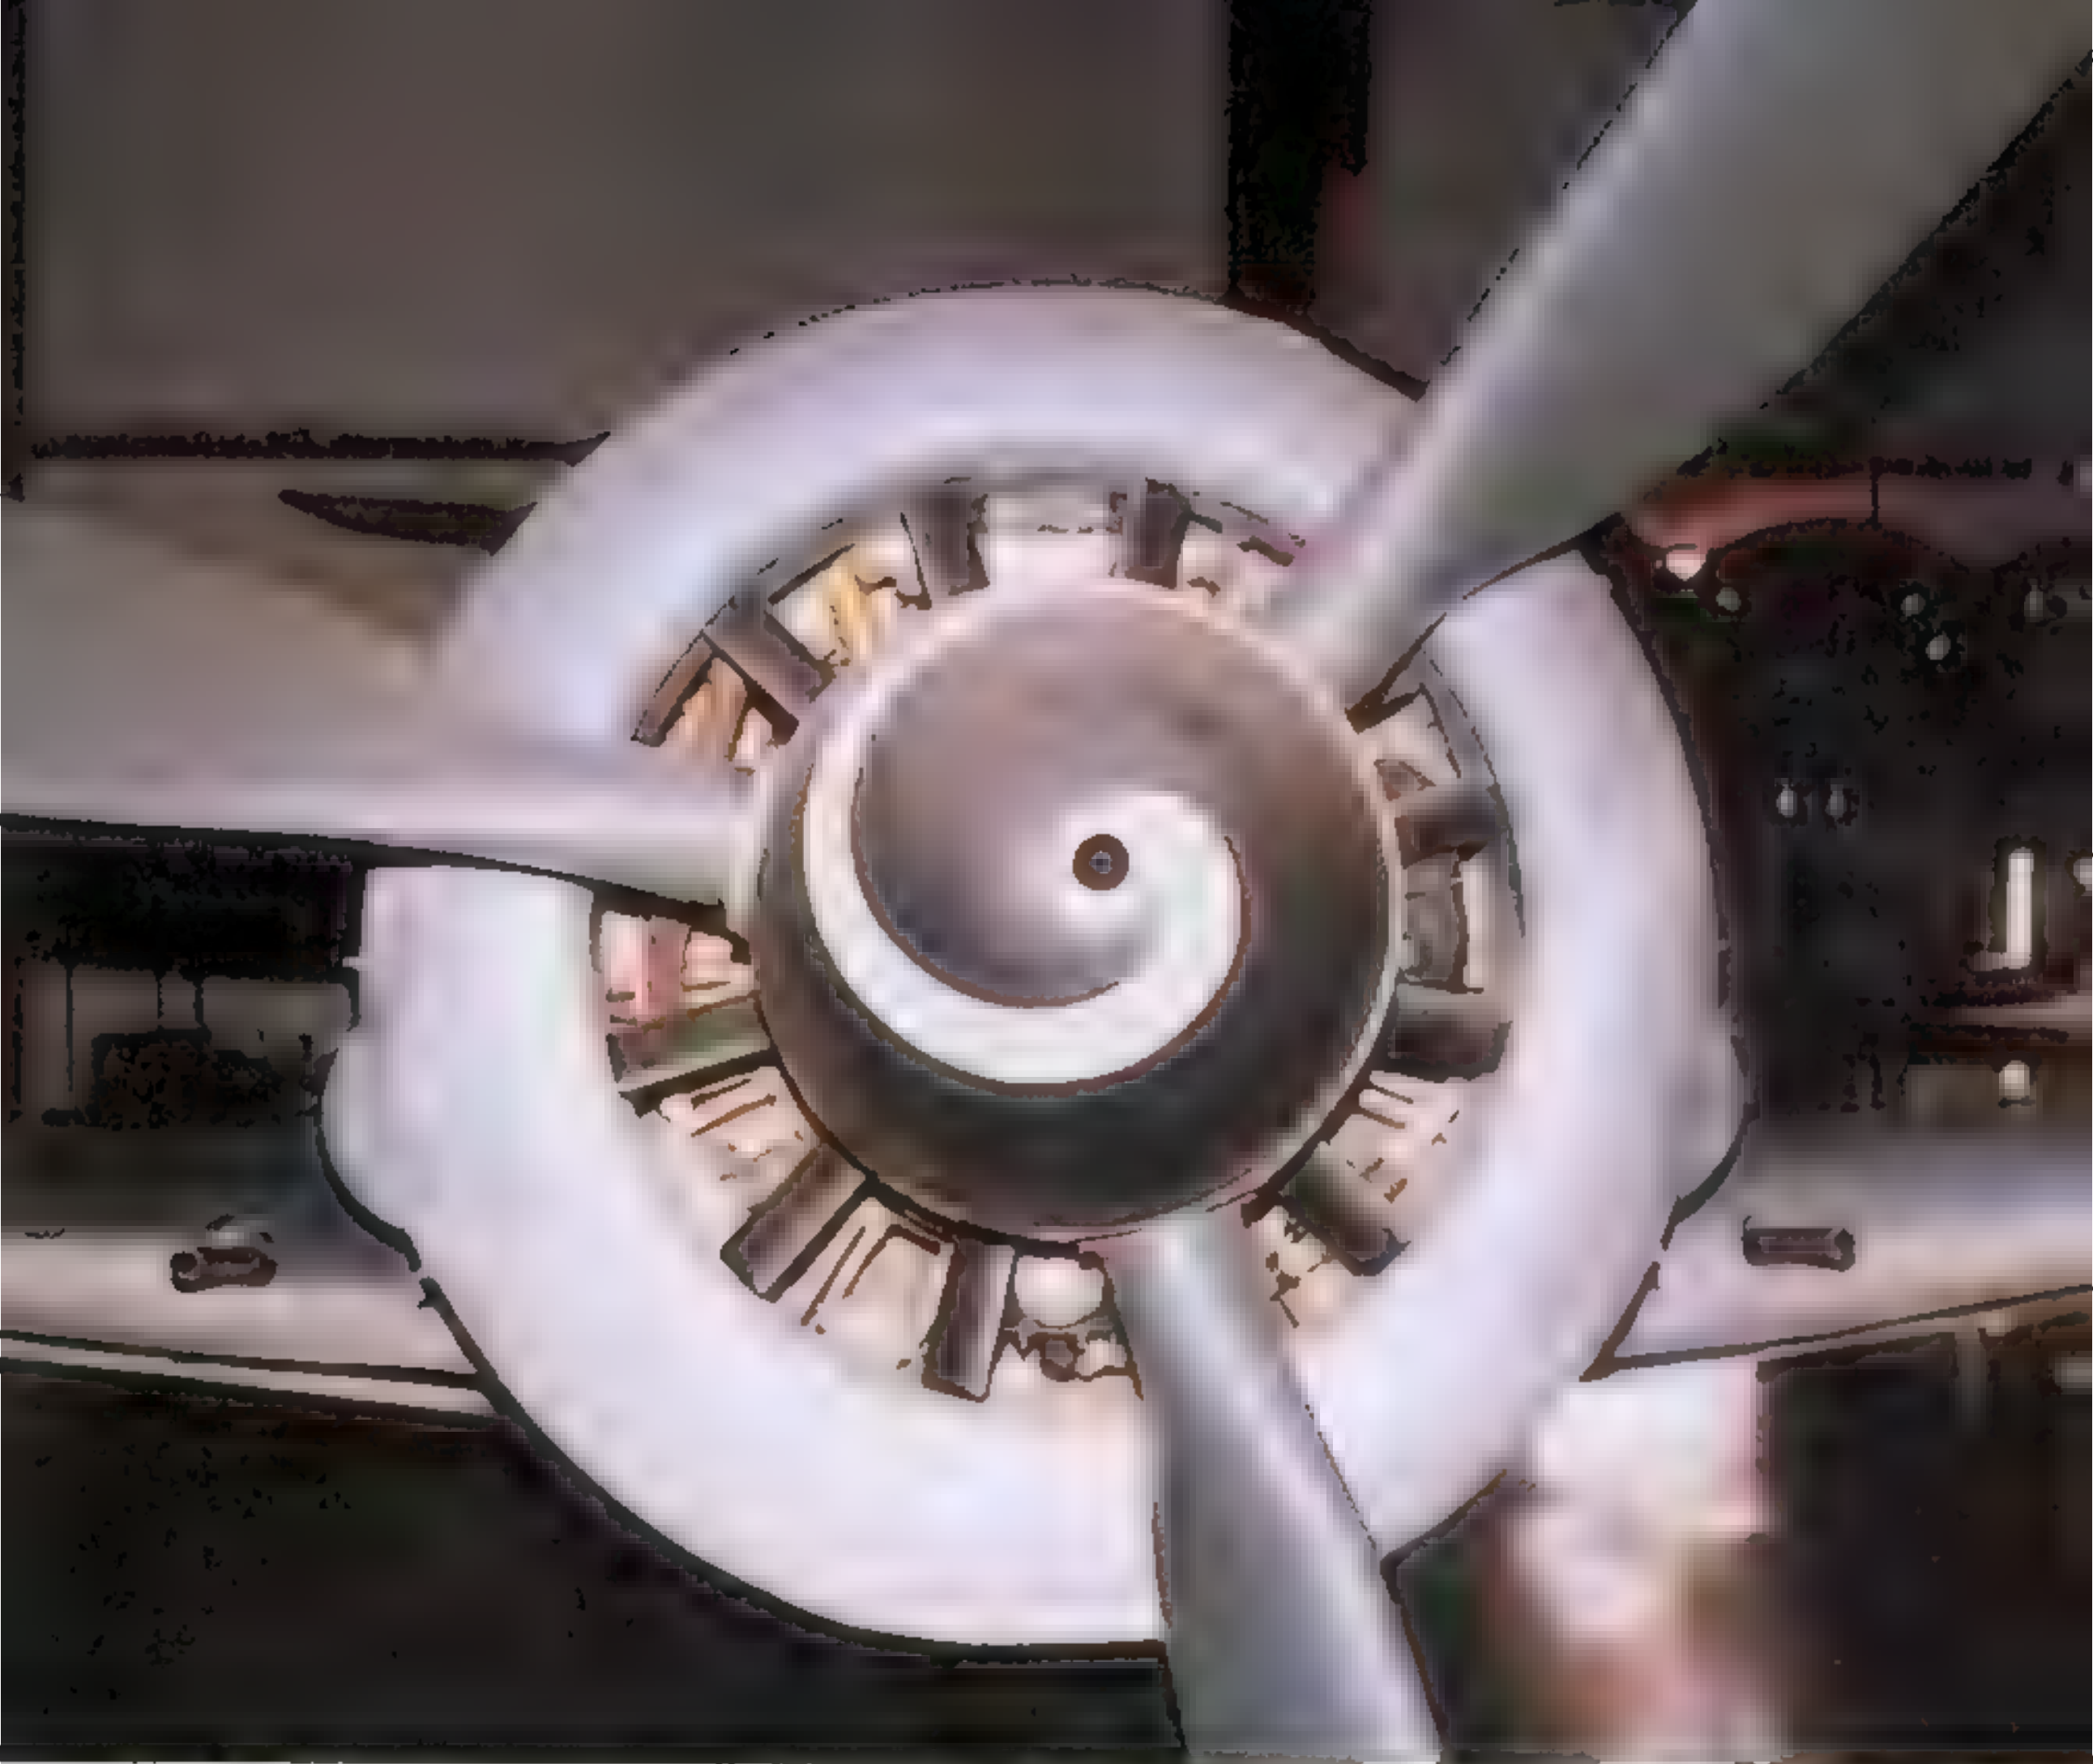
(Above) The Fw 190F-8 retained the same engine cowling and propeller spinner as the Fw 190As and earlier Fs. The spinner of the NASM's aircraft is painted RLM 22 Black (FS37038) with an RLM 21 White (FS37886) spiral for head-on recognition of Axis aircraft. The propeller blades are RLM 70 Black Green (FS34050). The forward cowling ring is protected by 6.5mm of armor, while the cowl has 5.5mm armor. The 1730 HP BMW 801D-2 14-cylinder air-cooled radial engine and its associated plumbing are mounted behind the 12-blade cooling fan retained from earlier radial-engined Fw 190s. One 20mm MG 151 cannon is mounted in each wing root. (Ryle)

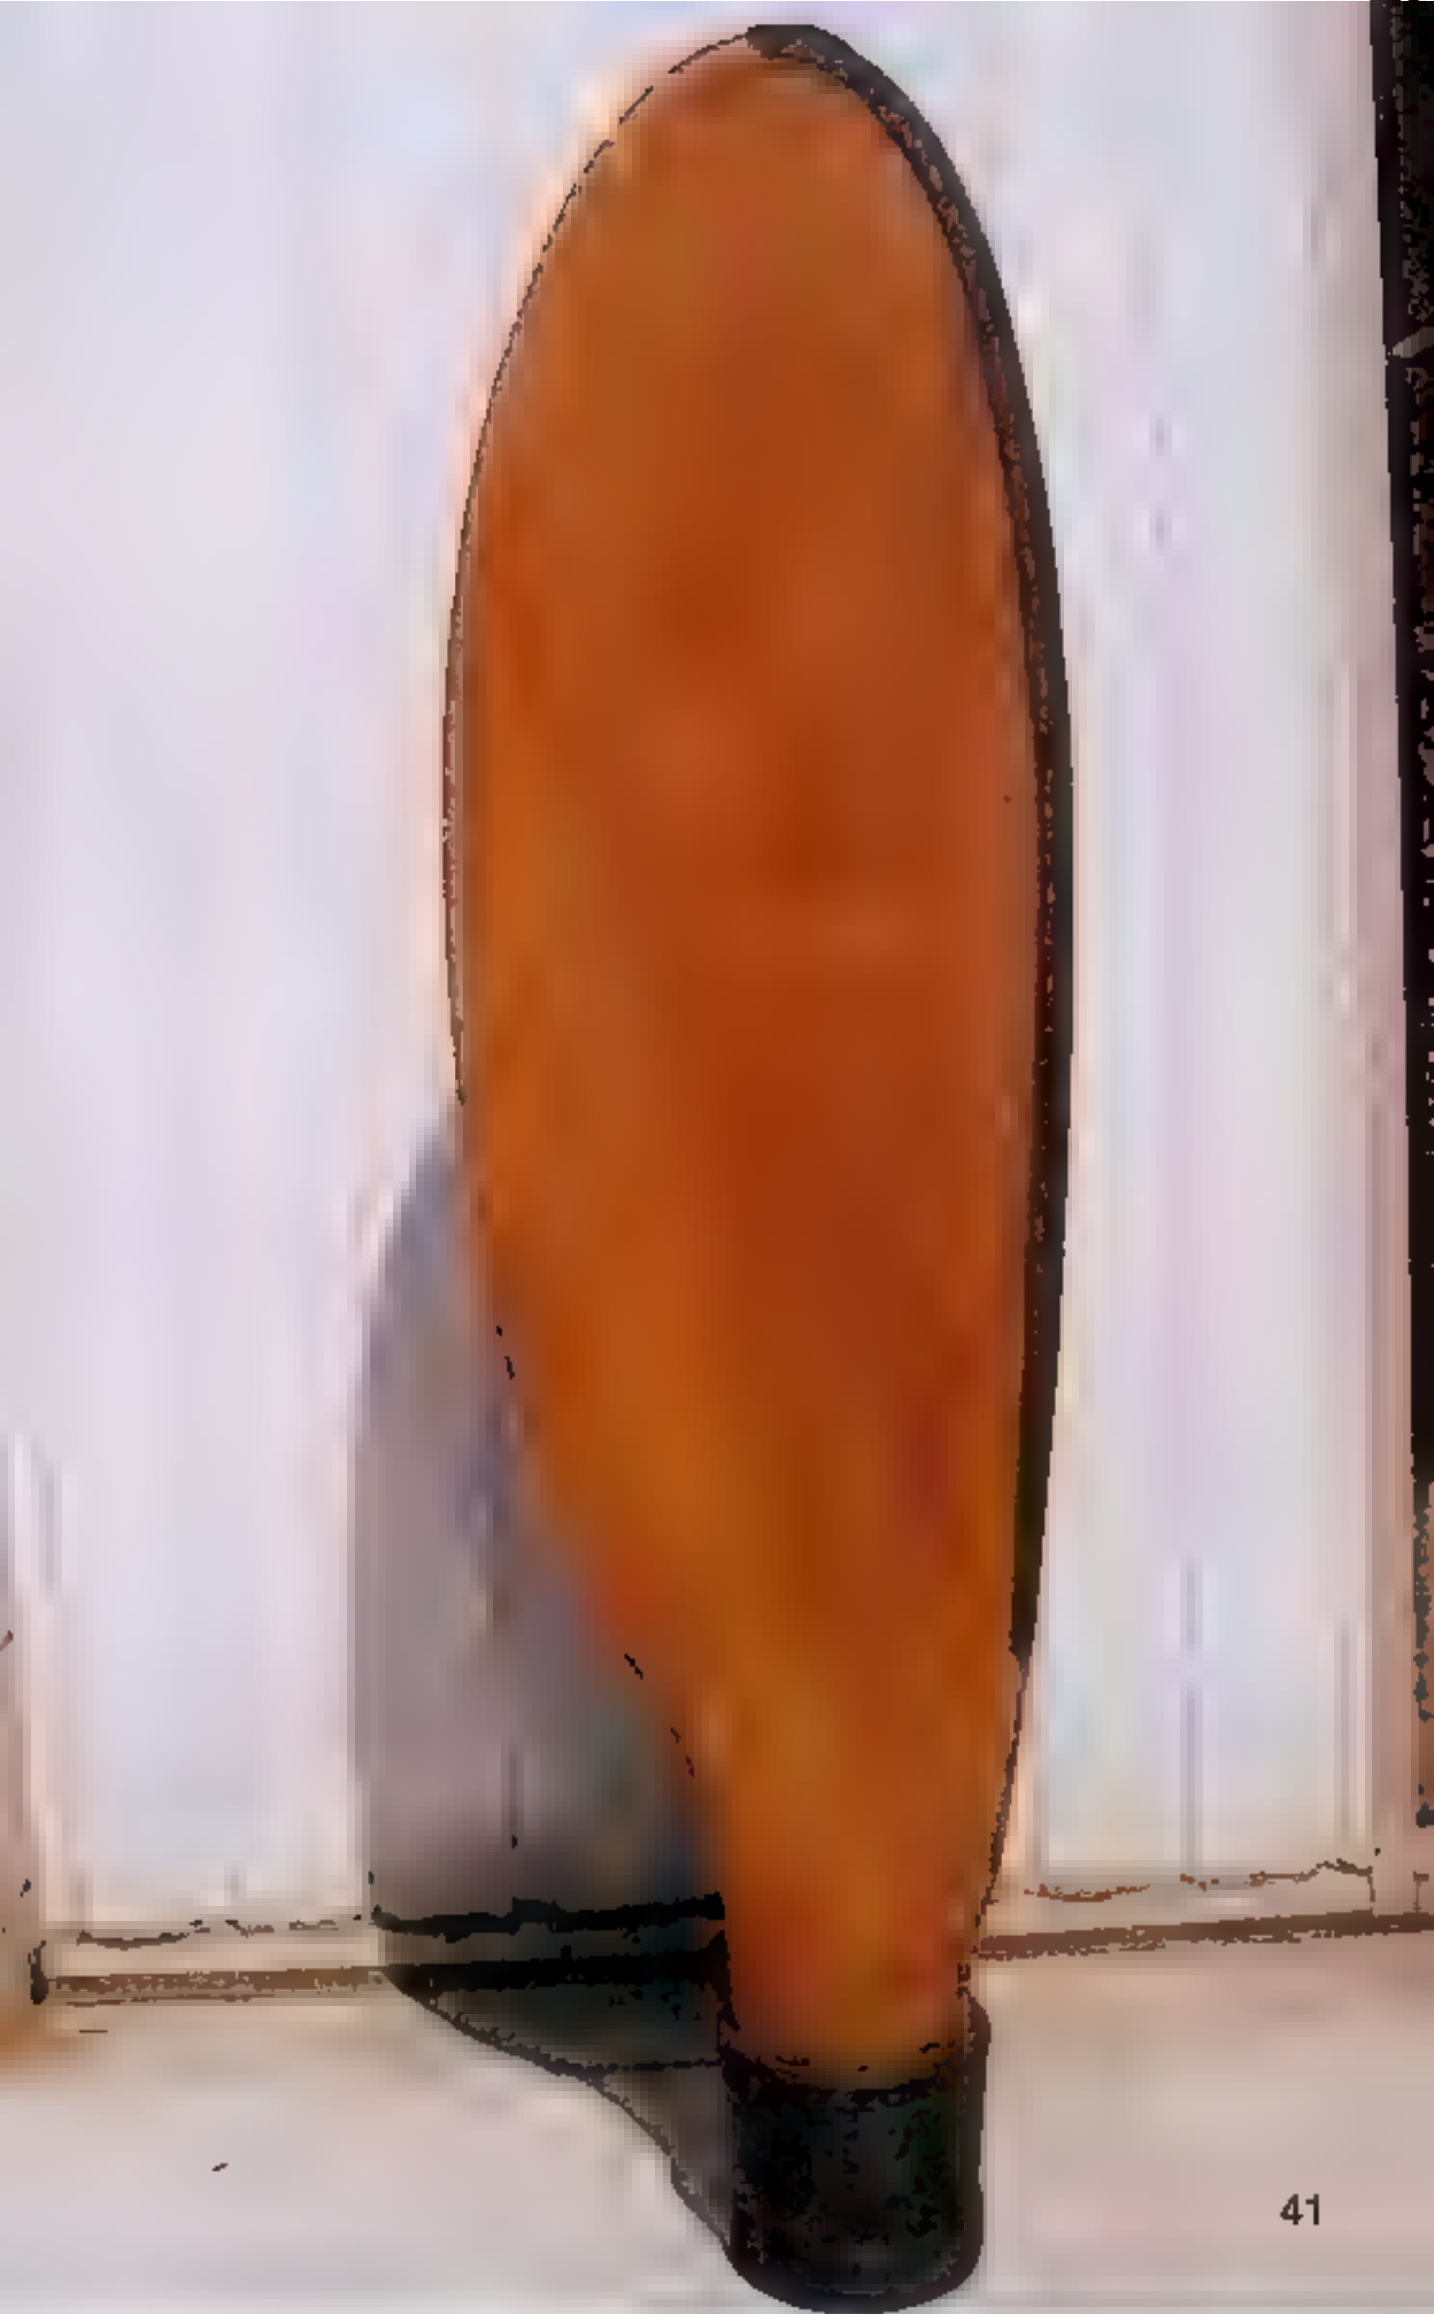
(Right) Fw 190Fs were fitted with three-bladed wooden propellers, whose paddle blades were designed to move large volumes of air. The blade is made from 1/32nd inch (0.85 cm) sheets of laminated wood glued together. The black painted brass leading edge was carefully inlaid into the wood. The wooden blade was covered with cloth, which was glued or doped to the wood, painted RLM 70 Black Green, and covered with a clear waterproof finish. The steel cuff at the base of the propeller blade fitted into the propeller hub. The Fw 190's propeller measured 10 feet 10 inches (3.3 m) in diameter, with automatic pitch control performed by the BMW 801 engine's control unit. Manual pitch control through electrical power was possible by the pilot's switching to manual control and using the thumb switch on the throttle to increase or decrease propeller pitch. (Ryle)

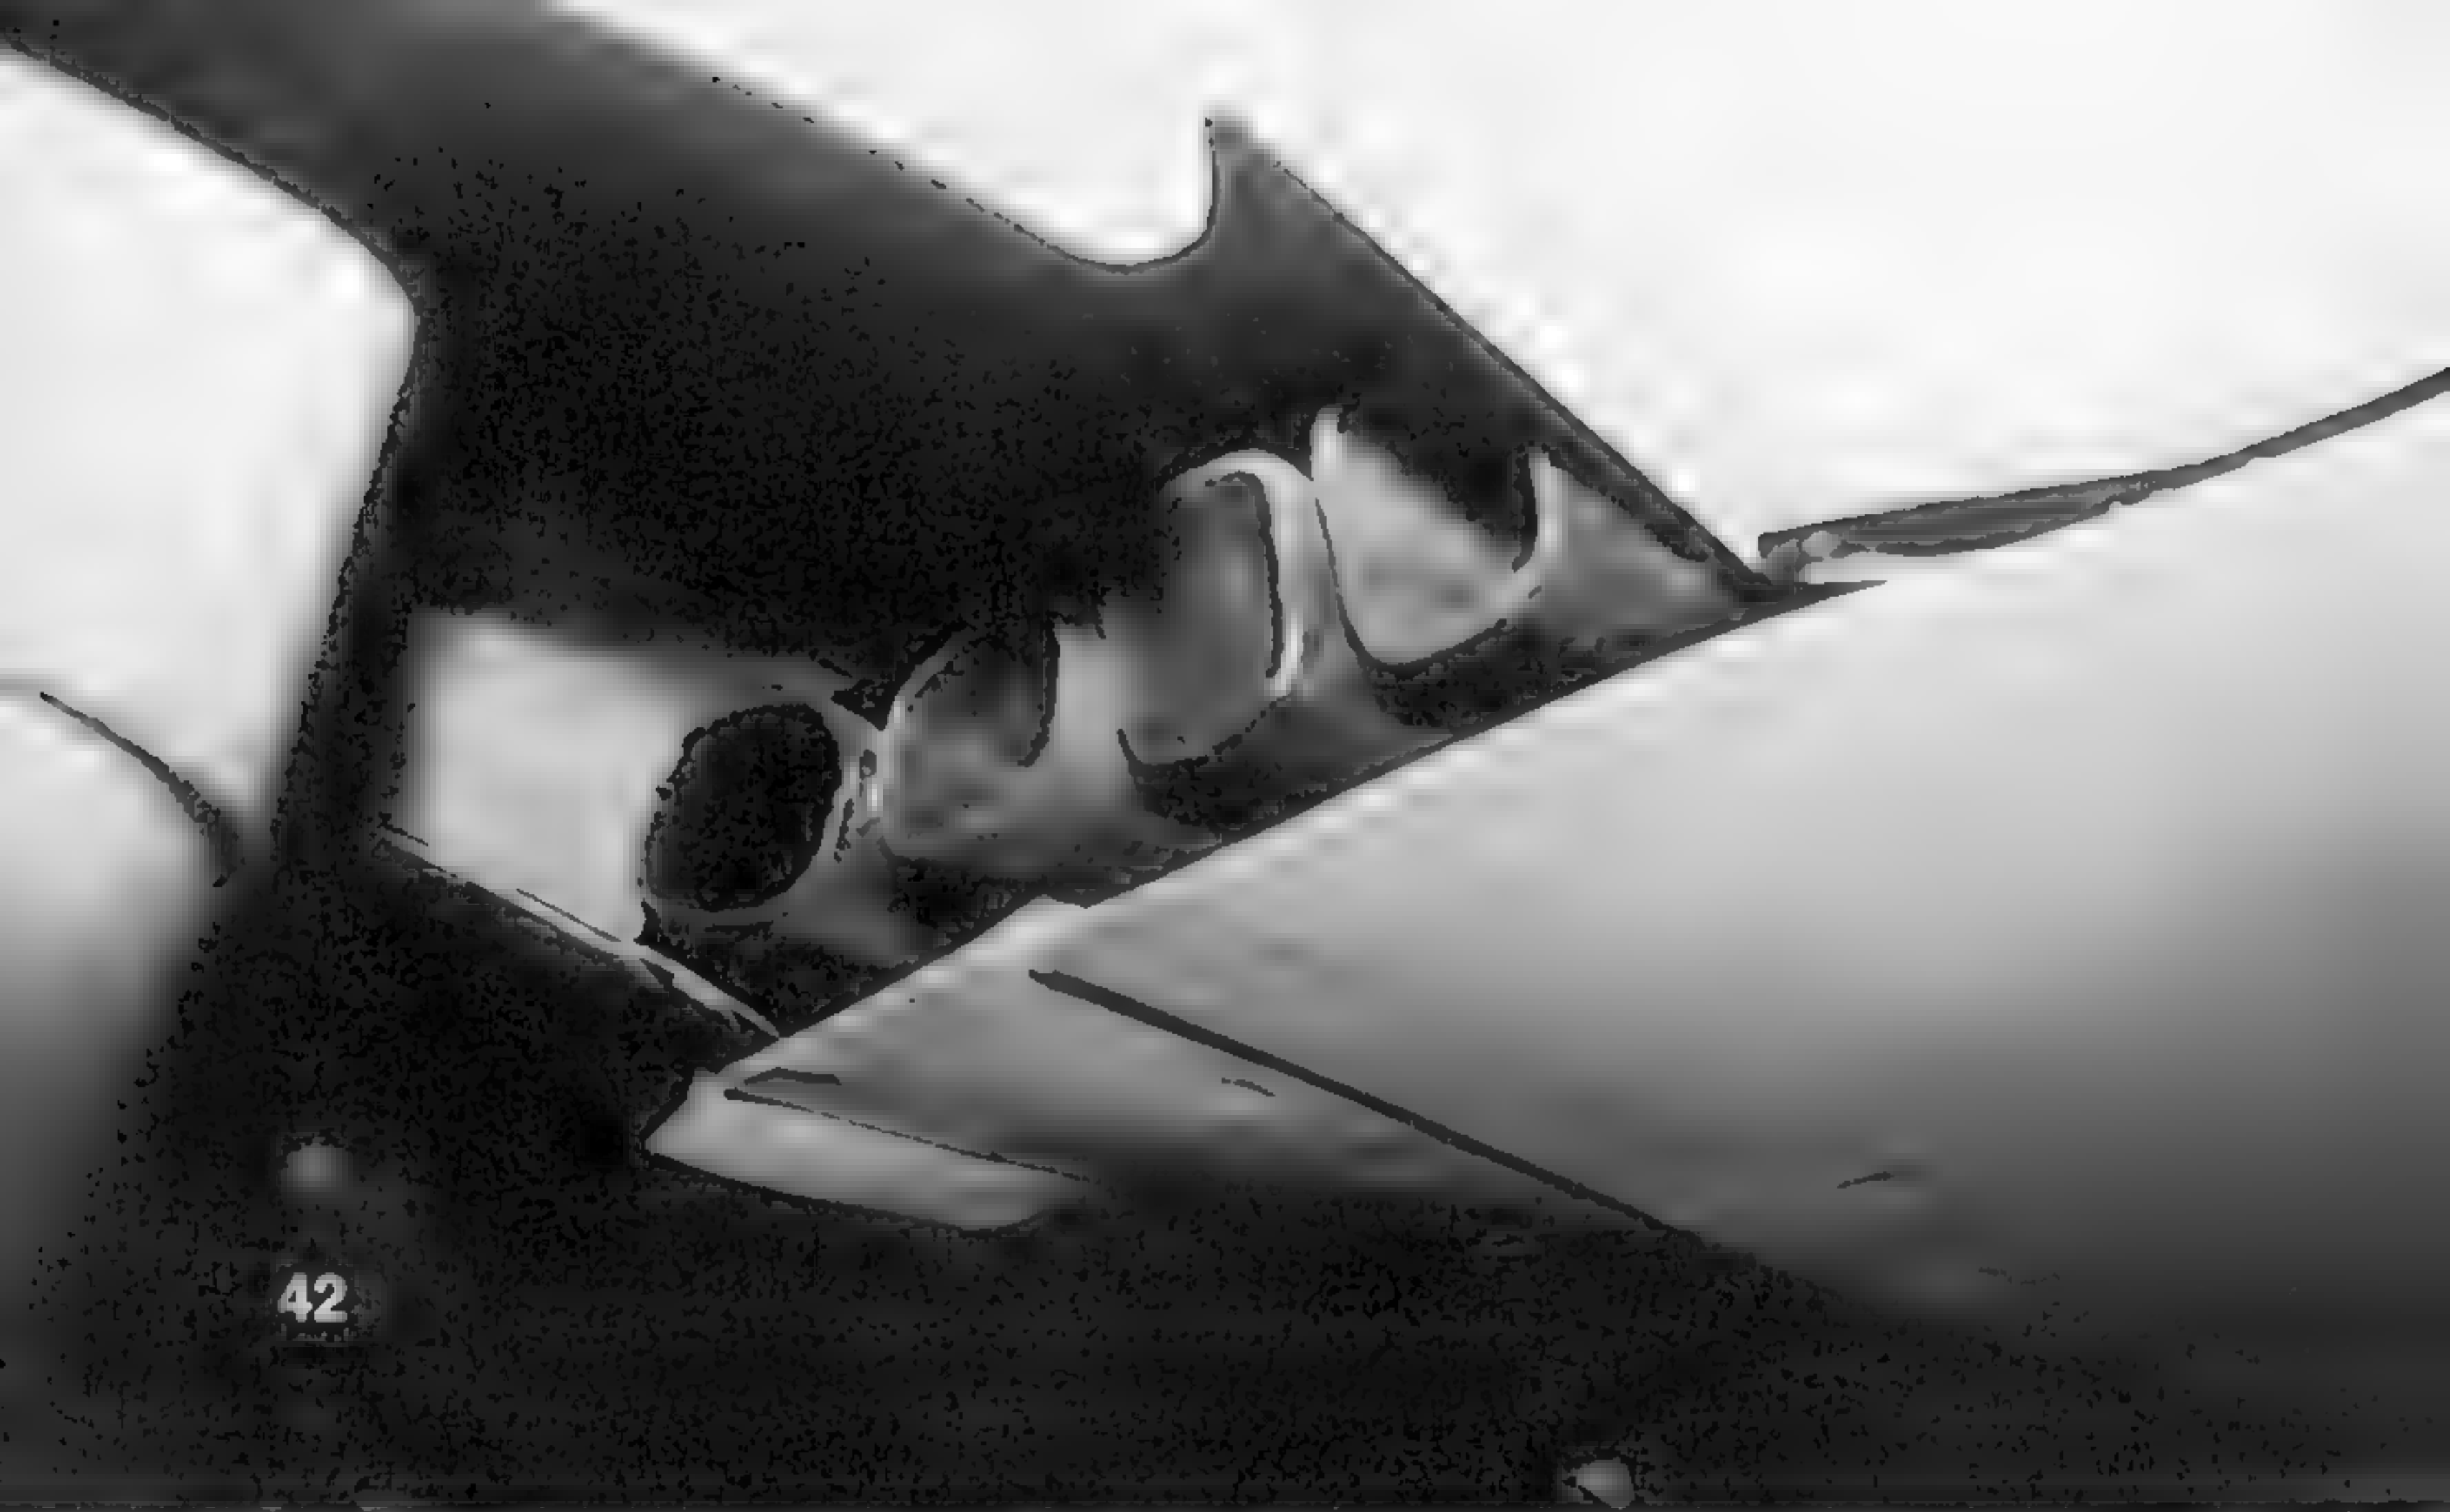
The lower engine exhaust bank for the (from right) 6, 5, 7, and 10/9 cylinders is on the Fw 190F-8's centerline. The 6 and 5 cylinder ports are vertical, the 7 and 10/9 stacks are horizontal, and the combined 10/9 port is the largest. The hot exhaust gases were channeled along the fuselage centerline by the shape of the exhaust area and the fixed fairing on the inside of the wheel wells. (Mautner)

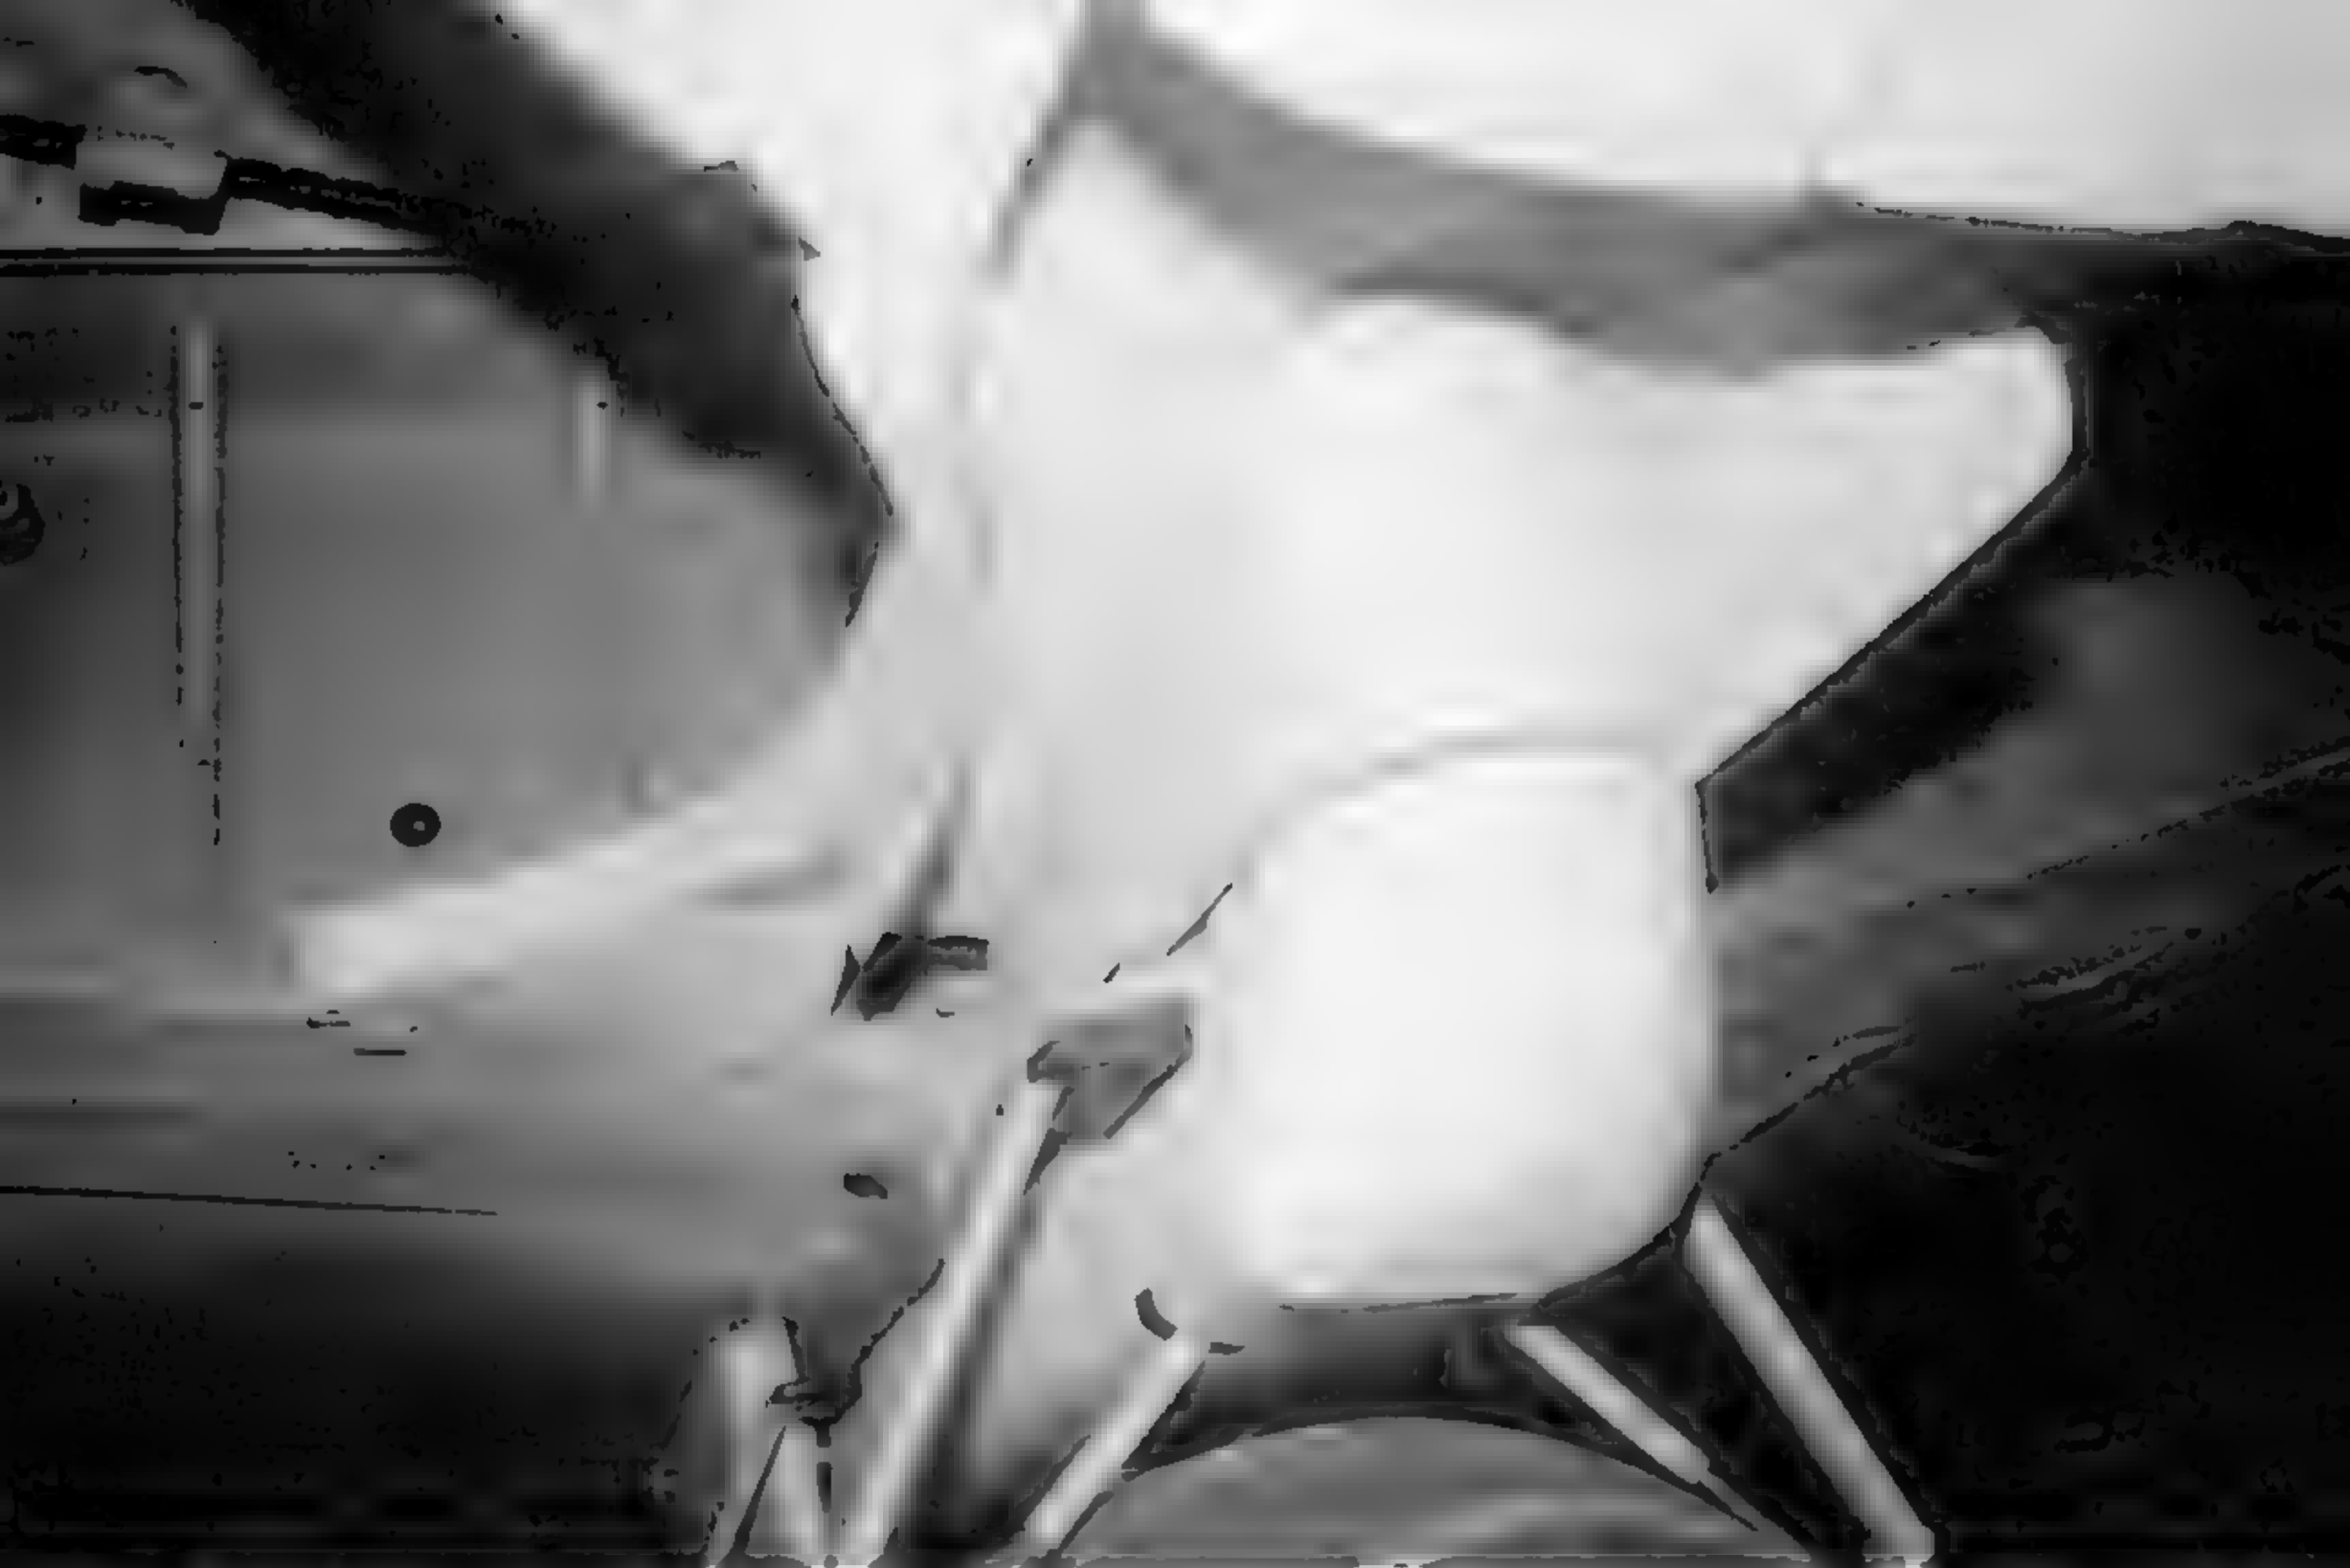
This ETC (*Einzelträger C-munition*; Single Rack with High-Explosive Bomb) 501 bomb rack and fairing was found in Norway and was originally installed on one of the Fw 190s now at the Texas Air Museum. It is currently installed on the NASM's Fw 190F-8. Small fixed fairings left and right of the rack were designed to channel gases from the lower exhaust bank away from the landing gear tires. The inner landing gear doors could not be used when the ETC 501 was installed. (Ryle)

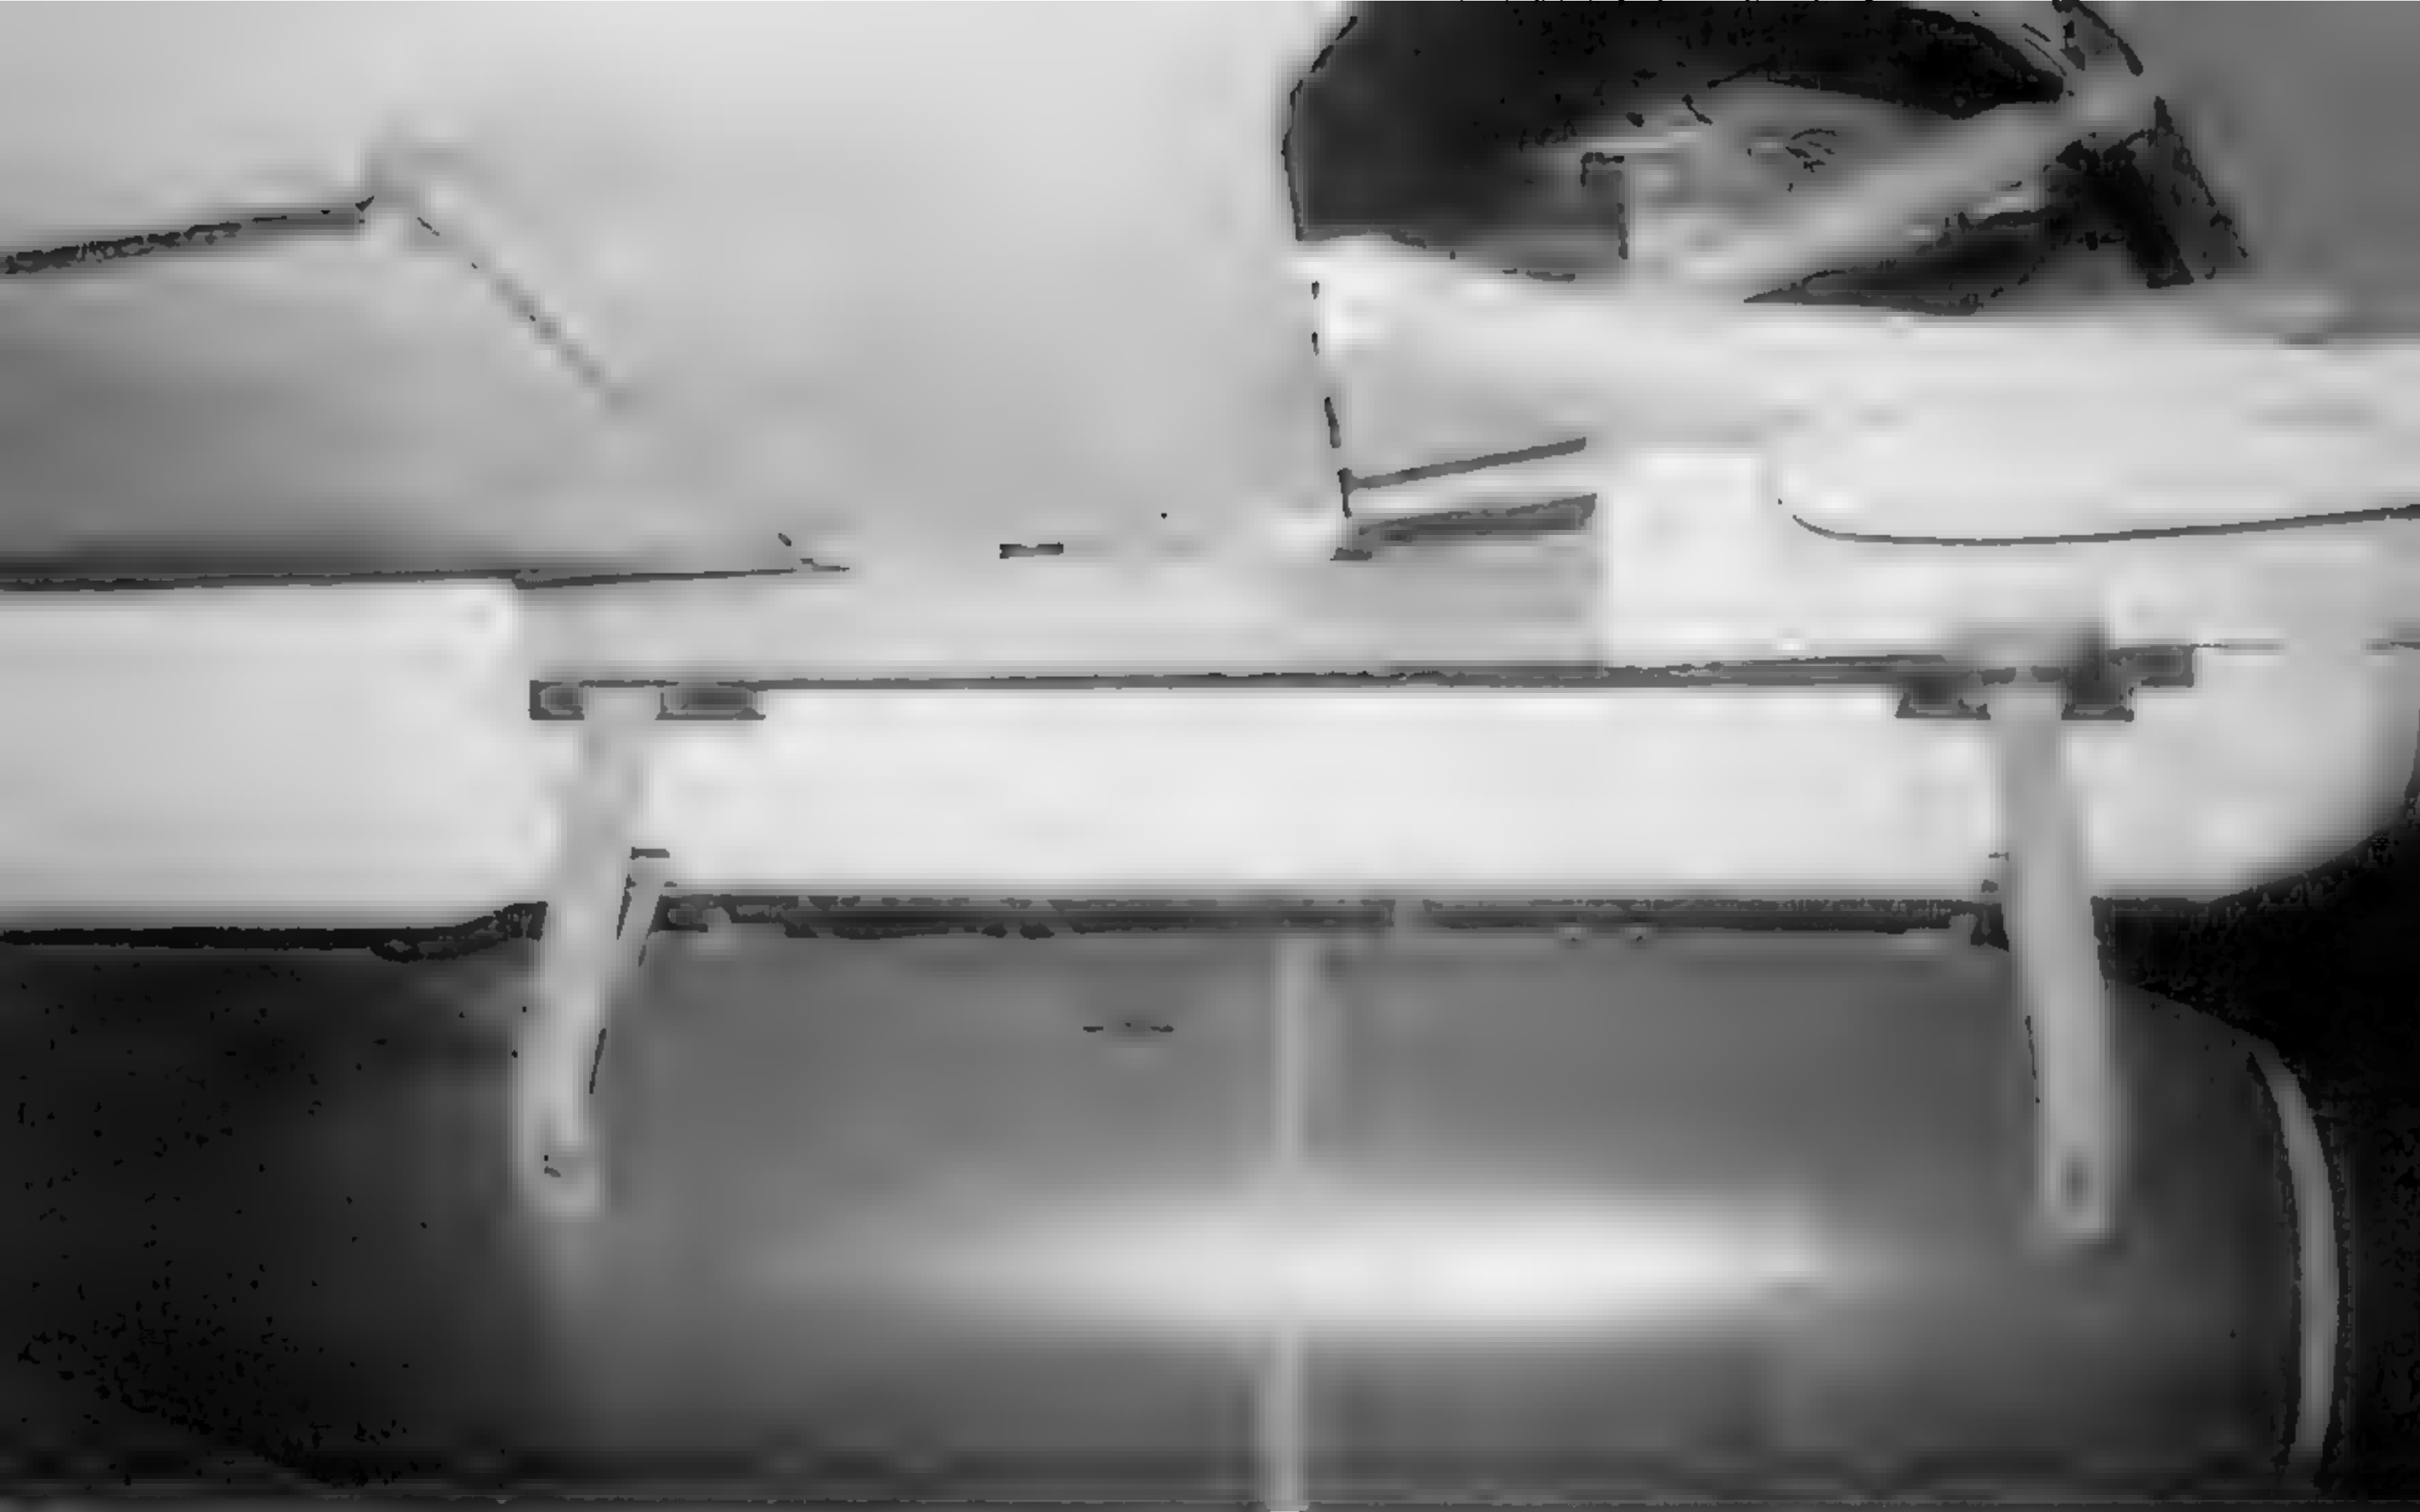
When the ETC 501 bomb rack was installed on the Fw 190A-8/F-8, the rack was moved forward eight inches (20.3 cm) from the location on previous Fw 190s. The move was required to rebalance the aircraft due to the new 30.4 gallon (115 L) auxiliary fuel tank in the fuselage aft of the pilot's seat. The 250 SC bomb is painted RLM 66 Black Gray (FS36081) with red stripes. Other standard colors for German bombs were RLM 02 Gray and RLM 76 Light Blue. (Ryle)

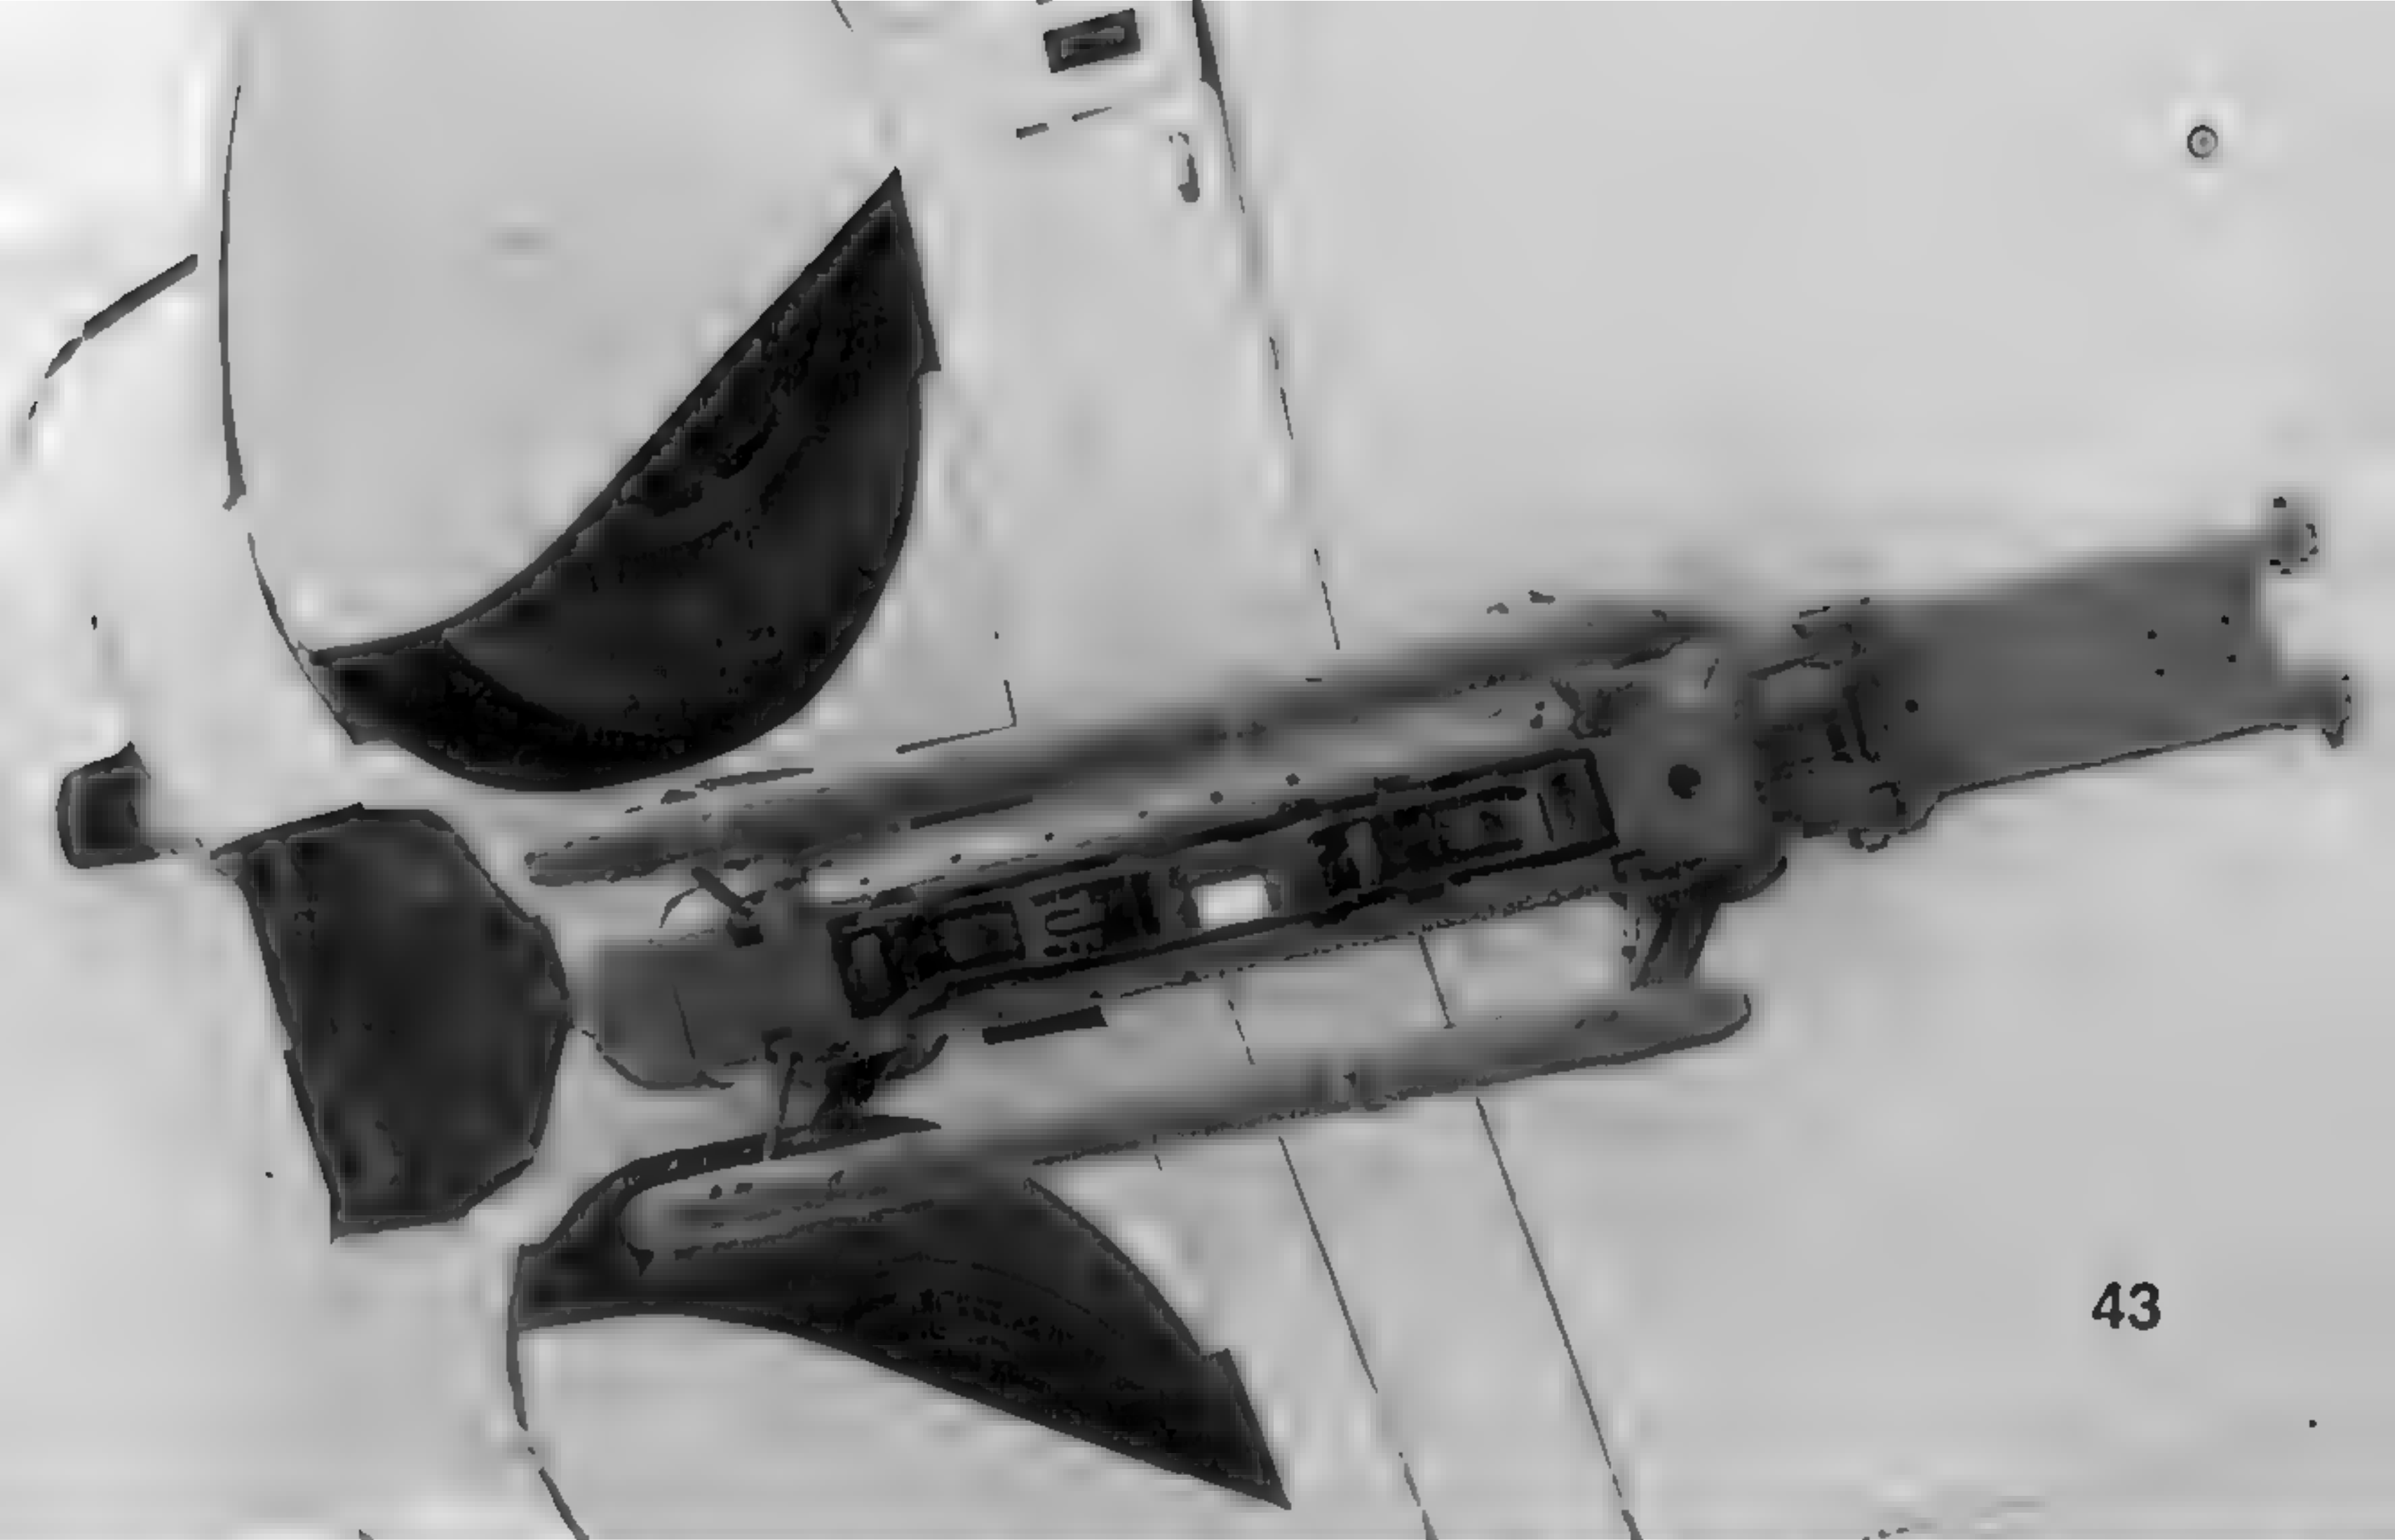
**An ETC 501 rack and carrier unit is installed on the Fw 190A-8 displayed at the Imperial War Museum in Lambeth, England. The three-piece aerodynamic fairing usually fitted to the rack is not installed here. The rack is set up for a 79.3 gallon (300 L) drop tank; however, none of the necessary wiring or plumbing is installed. (Fochuk)**
